# United States Fire Administration

## Technical Report Series

### Four Firefighters Die in Seattle Warehouse Fire Seattle, Washington

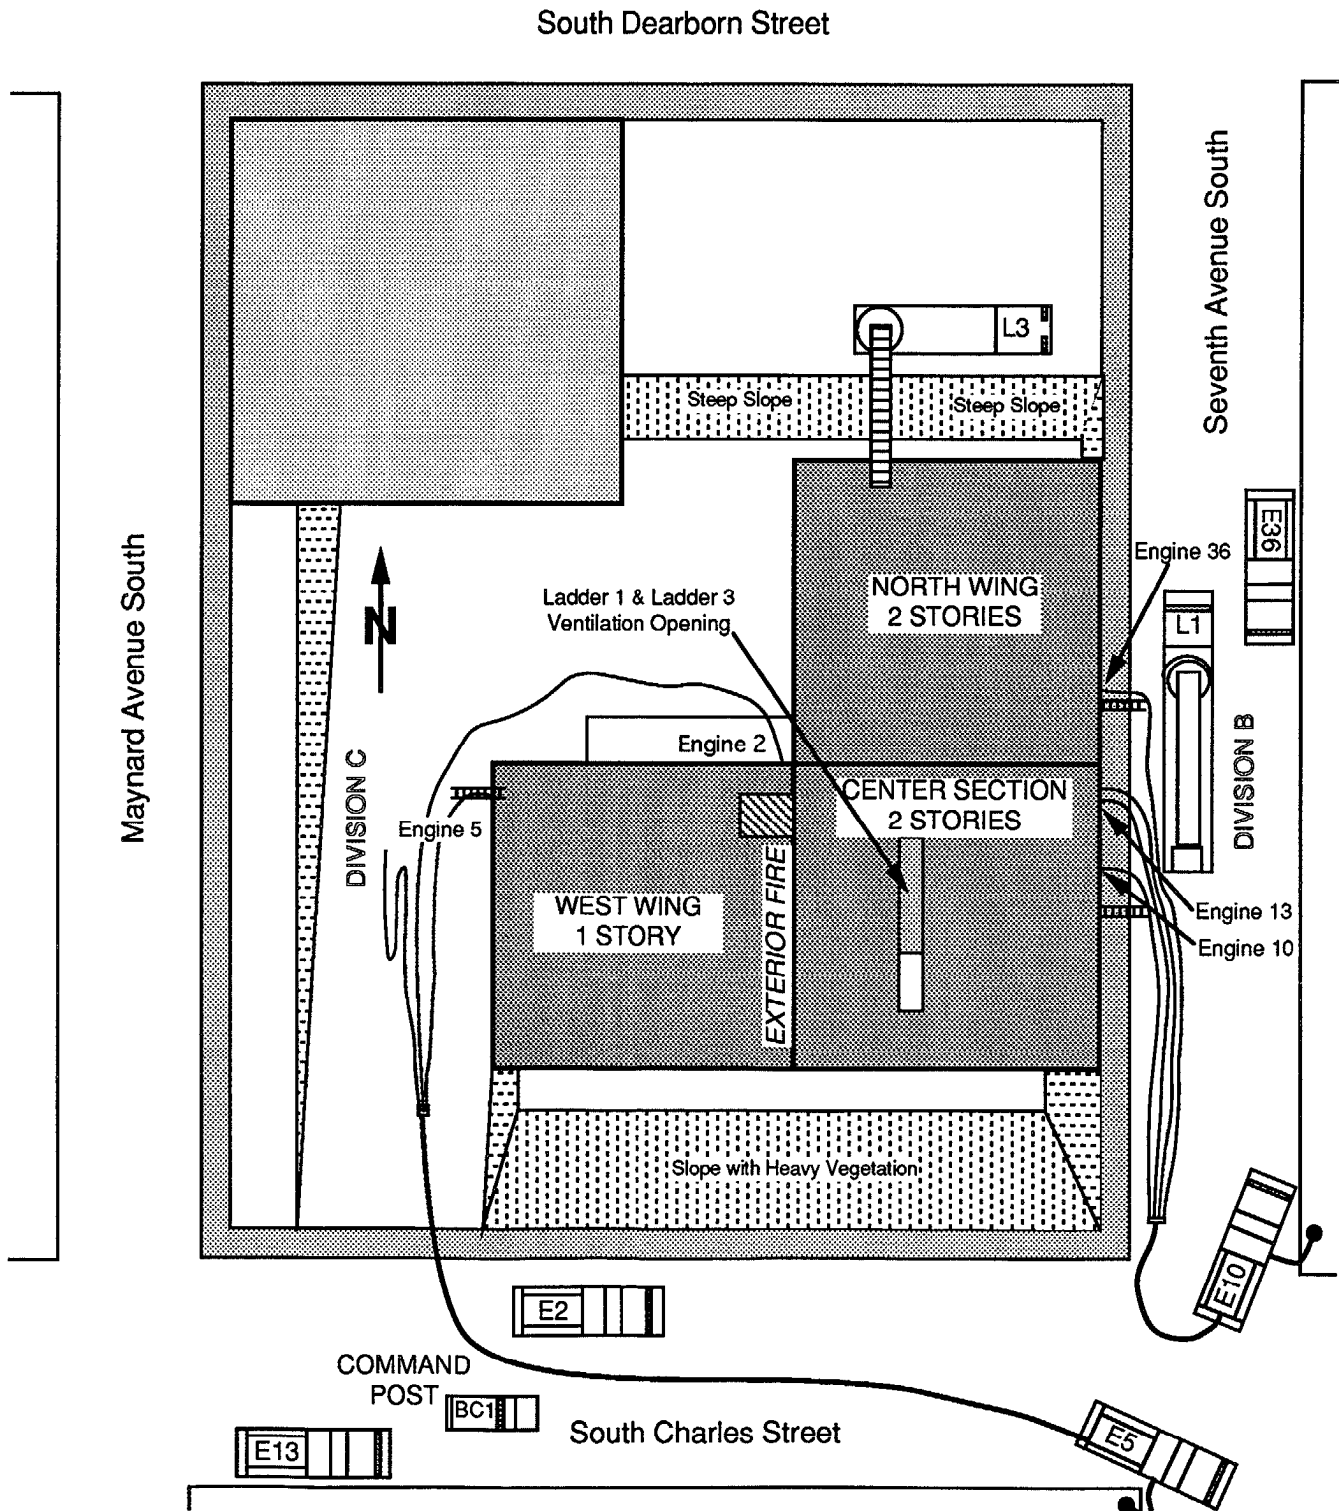
Figure 2

Ladder 3 approached from the east on South Dearborn Street and viewed the fire from the north. The Captain decided to place the ladder truck in the parking lot to the north of the fire building and to ladder the north wing. The crew then went to the roof with ventilation equipment. The deployment of first alarm companies is illustrated in Figure 2.

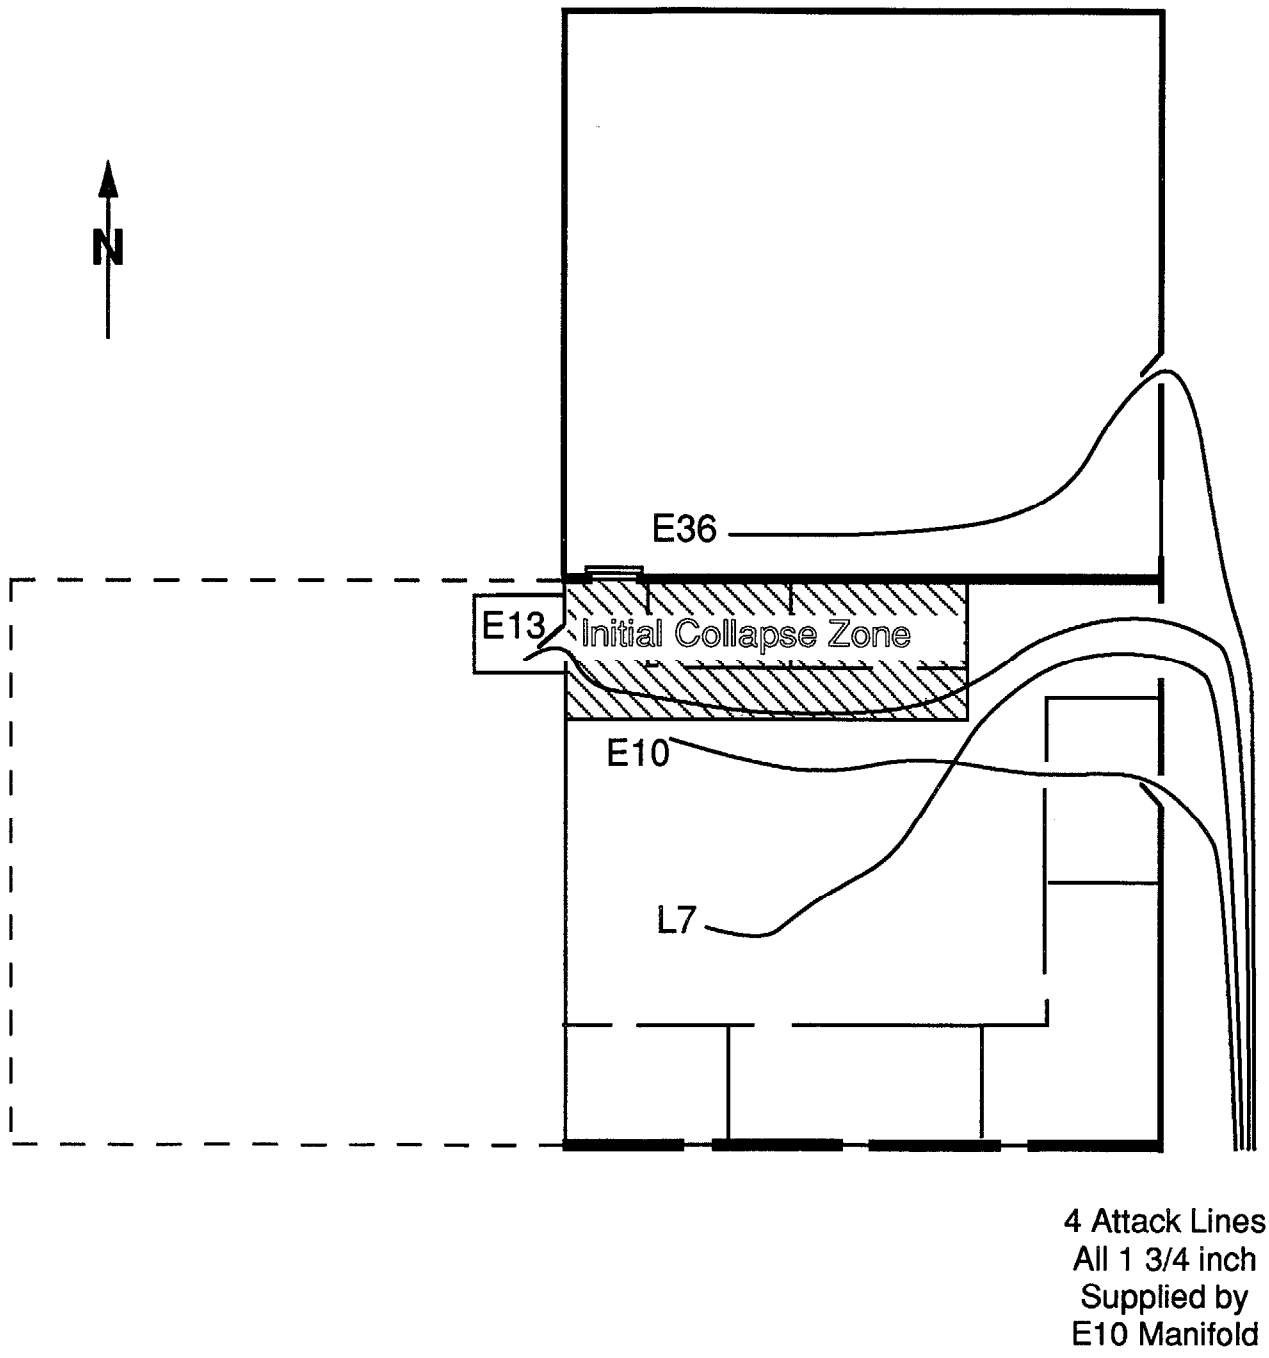
Figure 3

third line. (The approximate positions of the interior attack lines are illustrated in Figure 3.)

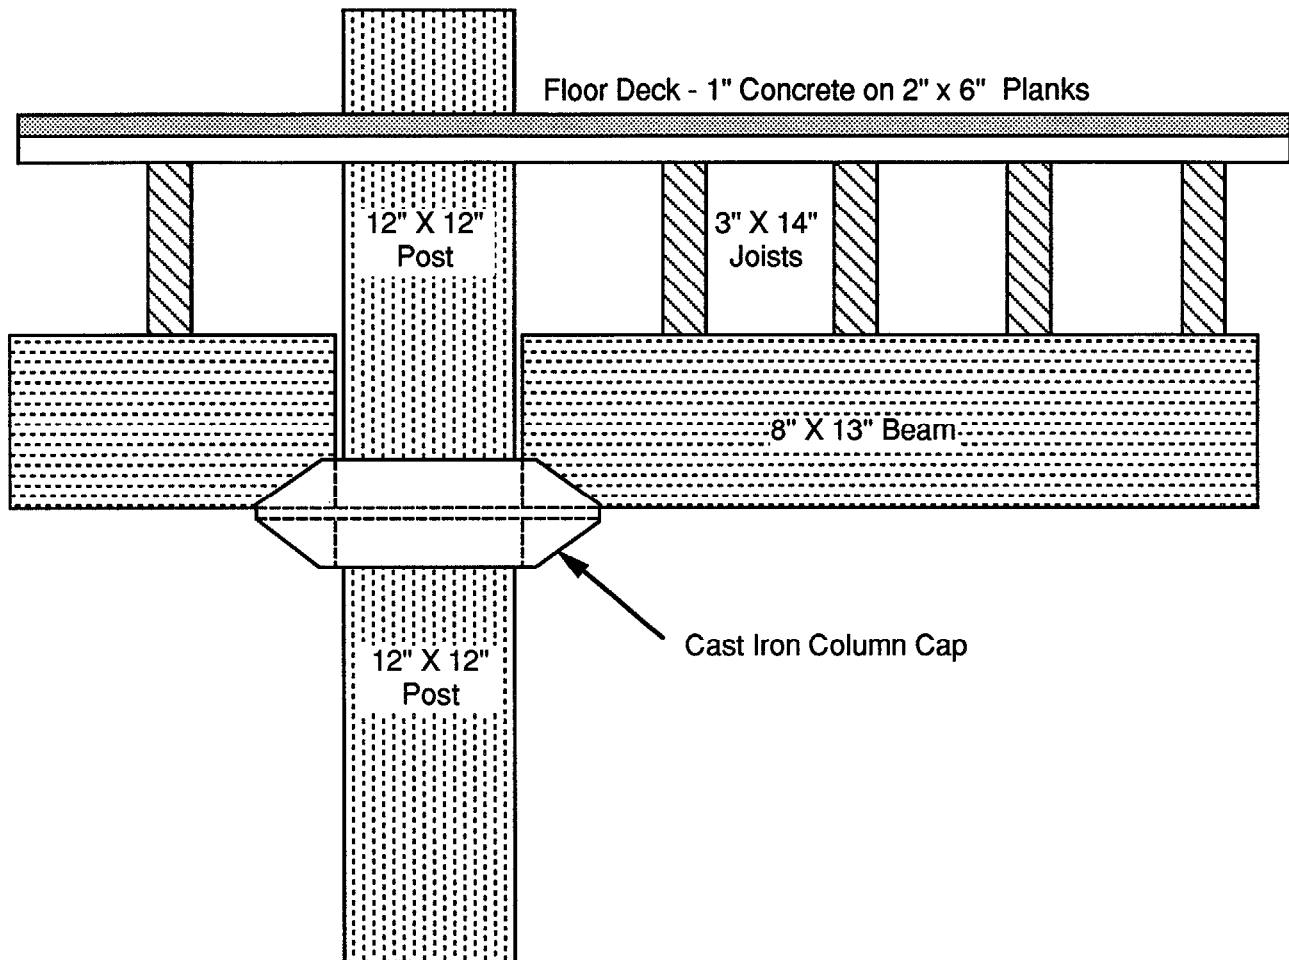
## DETAIL OF UPPER FLOOR DECK AND COLUMN CONNECTIONS

The hidden flaw in the structure was the support for the ends of the new floor joists along the north wall. The original roof was supported by a ledge that was incorporated in the brick wall. Because the new floor was four to five feet higher than the roof, a wood frame "pony wall" was fabricated from 2 x 4 inch wood members and erected on top of the ledge to support the ends of the new floor joists. This assembly did not have the inherent fire resistance of the more massive wood members and could be expected to fail rapidly under fire conditions. The failure of this assembly would release the ends of the floor joists and result in a sudden floor collapse.

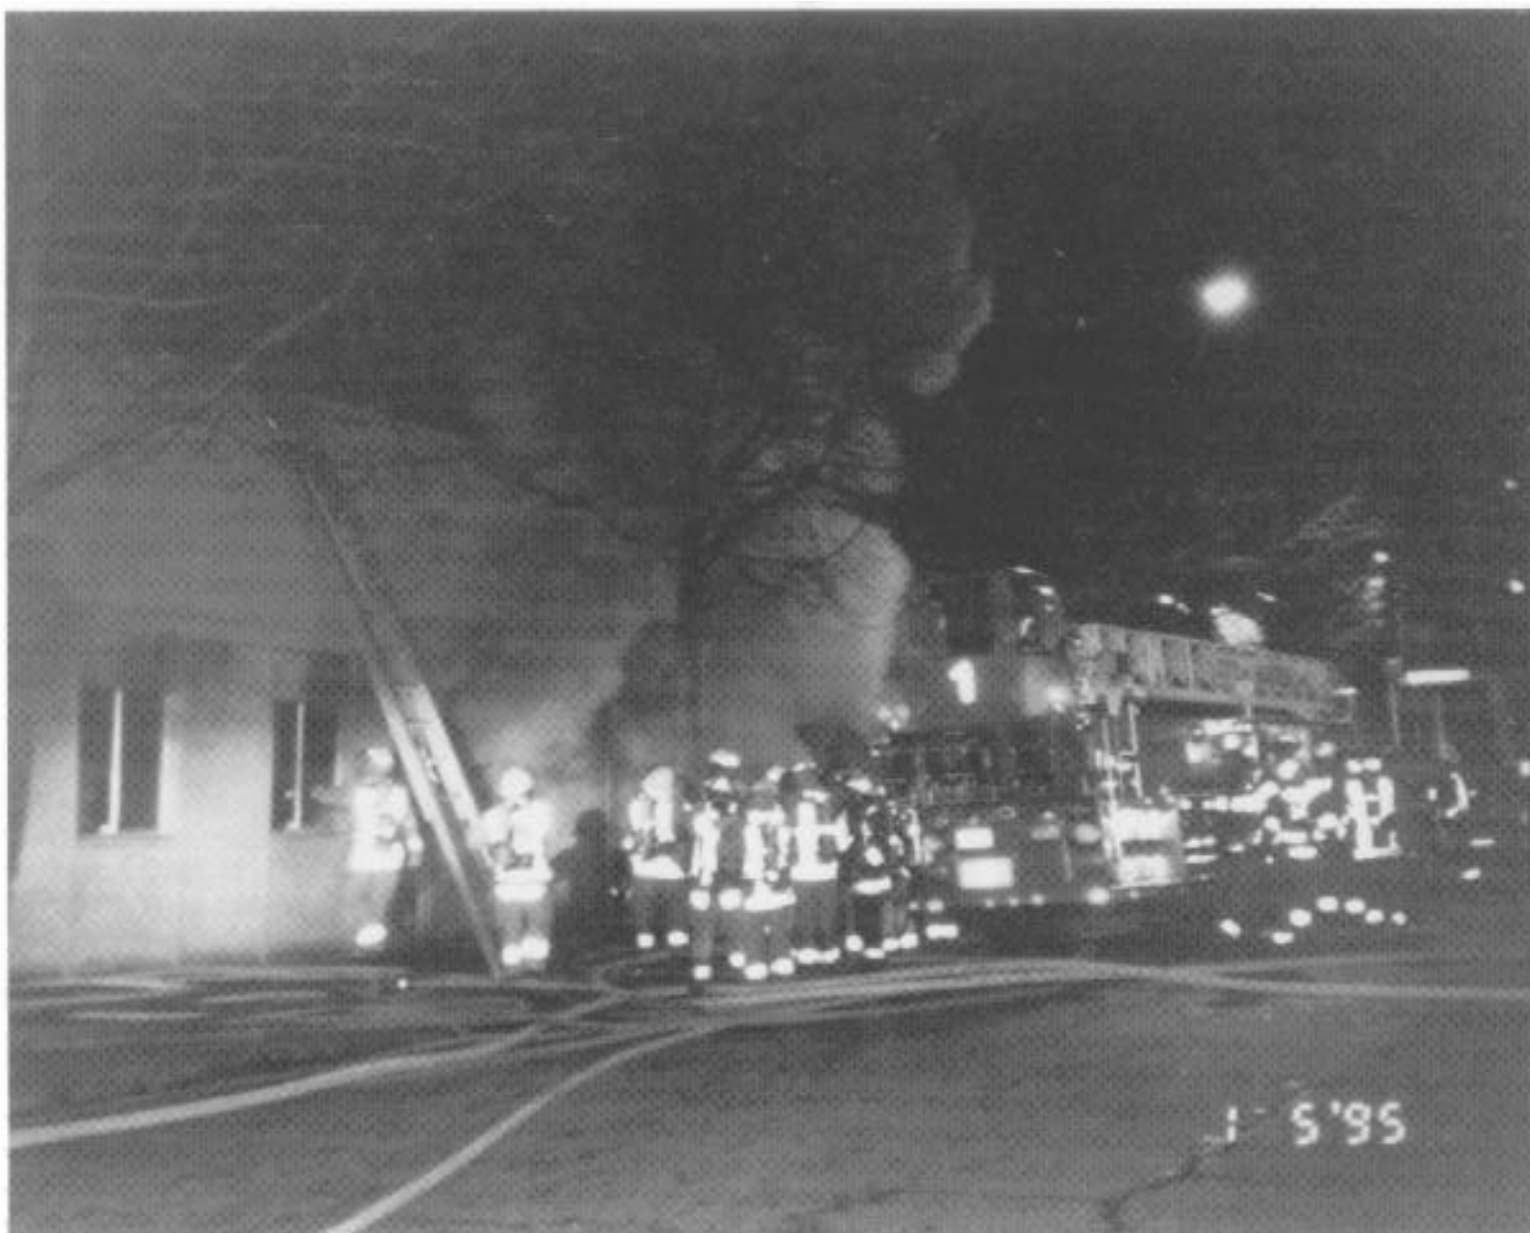
Crews prepare to enter the structure on the east side.
